Residential Quietude, the Top Luxury Requirement

The acoustic requirements and laws and the secrets to meeting them for single and multifamily residences.

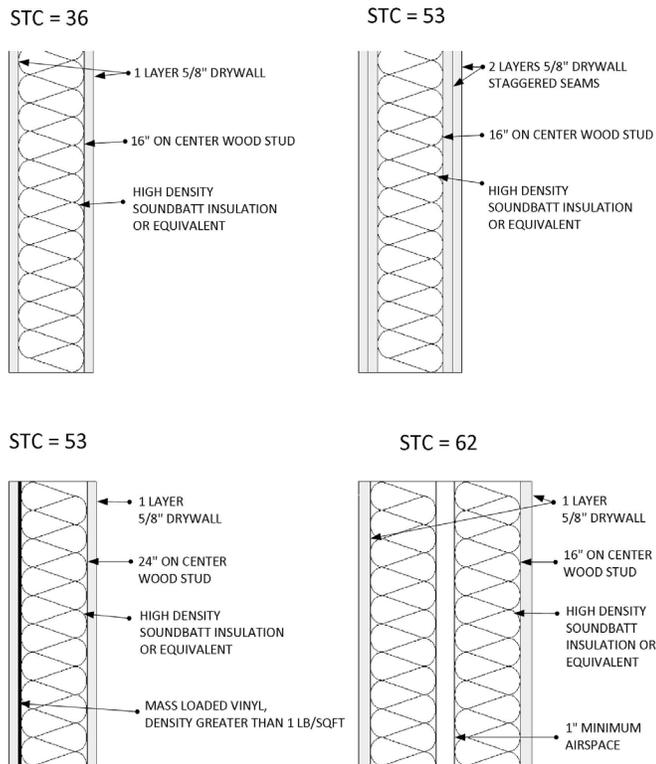
Figure 1. Examples of standard walls and their sound transmission classes (STCs). The figure shows how walls are constructed to give different STC values.

Books have been written about various wall configurations (Beranek, 1991; Harris, 1998). At this time, giving an acoustic value to standard walls, as shown in **Figure 1**, will facilitate the conversation of laboratory versus field results, something that is often overlooked or not understood.

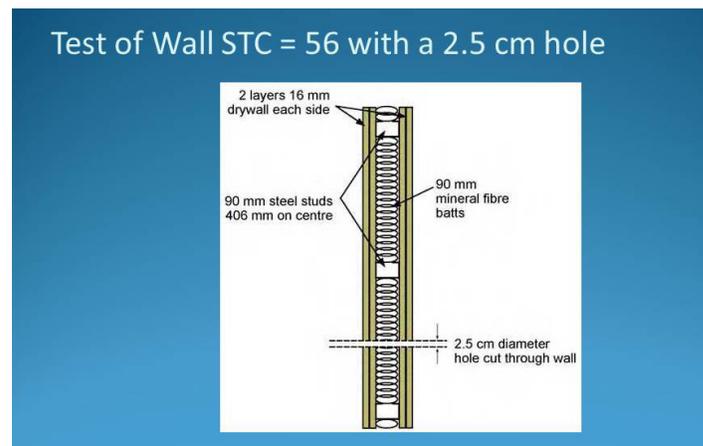
Figure 2. Configuration of a test wall with 2.5-cm-diameter hole. The figure shows a wall that was constructed with a small hole to be tested for field sound transmission class (FSTC) degradation.

(NCRC) is discussed (Gover and Bradley, 2006). To further clarify discrepancies between laboratory and field results, one of the many tests performed by the NCRC is provided in **Figure 2**. This example is worth noting because this is roughly equal to acoustically untreated electric outlets installed back-to-back.

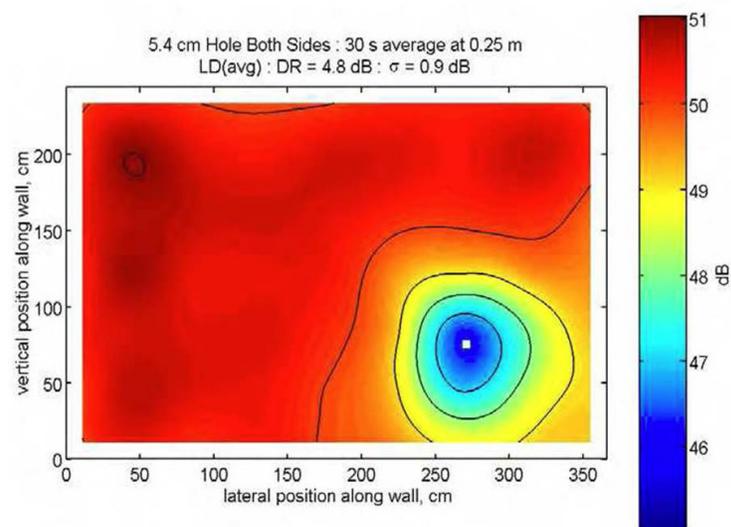
Figure 3. FSTC results of **Figure 2** test wall with 2.5-cm-diameter hole. The figure shows the results of the FSTC degradation of as much 10 points due to the 2.5-cm-diameter hole. LD, level difference; DR, dynamic range; σ , standard deviation.

Figure 3 presents the laboratory results from a one-inch hole that was created in a wall with a design STC of 56. The wall measured at a distance from the hole has a field sound transmission class (FSTC) of 51, but near the hole, the wall has a FSTC of 41.

The difference between these two readings is the difference between being able to hear someone talking through a wall or not. This reference to the extensive research at CNRC testing is included in this paper to demonstrate the importance of understanding the ASTM laboratory versus field ratings and the variables that create the difference between them. This difference in the results between the STC and FSTC not only emphasizes the importance of correct installation but also the importance of designing to the FSTC rather than just the STC for noise sensitive clients or applications.

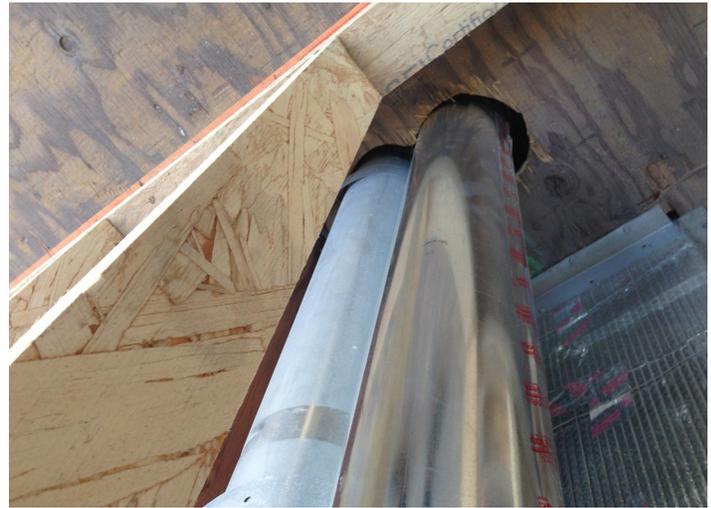
Figure 4. Picture of pipes passing through the floor creating a hole in the floor configuration. This figure shows a typical example of a small hole that degrades the FSTC of a floor, allowing sound to freely pass from one floor to another.

Acoustically treating all seams or openings in walls and ceiling/floor configurations demonstrates the vital importance of a continuous site inspection and testing of an installation, often referred to in the construction world as construction administration. The purpose of construction administration is to ensure that the construction not only conforms to the construction documents but also to identify and resolve construction problems early. The focus on minimizing any acoustic leakage points should also consider light fixtures in a ceiling. The recessed lights should be in an insulated enclosure with a high STC. If this is not possible, there are mufflers available that can be installed above these “holes in a ceiling.” Other simple examples of small holes in construction that are a source of acoustic leakage are back-to-back electrical outlets, the space under a door, or something as simple as pipes that run between floors. Whether it is a single- or multifamily home, pipes are often hidden in a shared chase or are in a wall behind which are ducts. When a duct or pipe passes through the floor/ceiling, a hole needs to be made to pass the conduit. If this hole is not properly sealed, sound will easily pass from floor to floor, diminishing the effectiveness of the acoustic treatment, as shown in **Figure 4**.

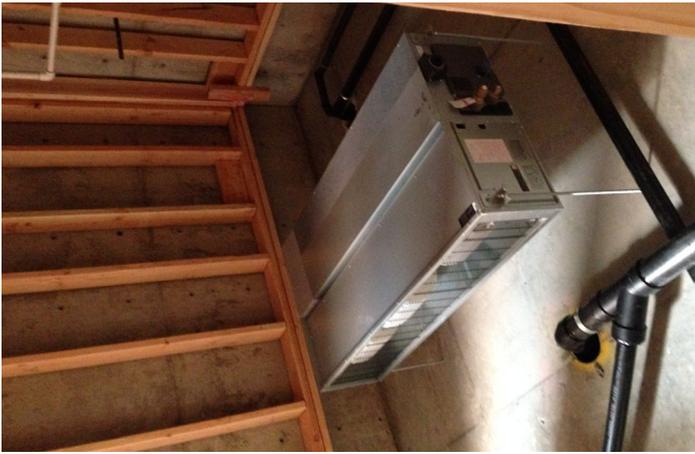
Figure 5. Picture of a loud mechanical unit near a pipe penetration in the ceiling. This figure shows another example of how sounds from a mechanical unit can easily pass through a hole a pipe passes through that has not been acoustically sealed.

Another example was when I had a client complain about hearing mechanical noise from the room below. There was some structure-borne noise, but there was also a great deal of airborne noise that should not have been present based on the design of the floor, which was 200 mm of poured concrete. On inspection, a pipe was found next to the unit that passed through the ceiling and cut through the floor into a wall above, as shown in **Figure 5**. There was only one layer of sheet rock between the pipe and the client’s bedroom.

Although the pipe was cast iron, the hole that needed to be cut for the pipe to pass through the concrete was such that enough sound entered into the hole and into the stud bay above, making it possible for the sound to easily travel through the one layer of sheet rock and into the bedroom.
