# PROFESSIONAL STUDIOS: HERE'S ANOTHER FINE MESS YOU HAVE GOT ME INTO

Marshall Long

## Professional studios

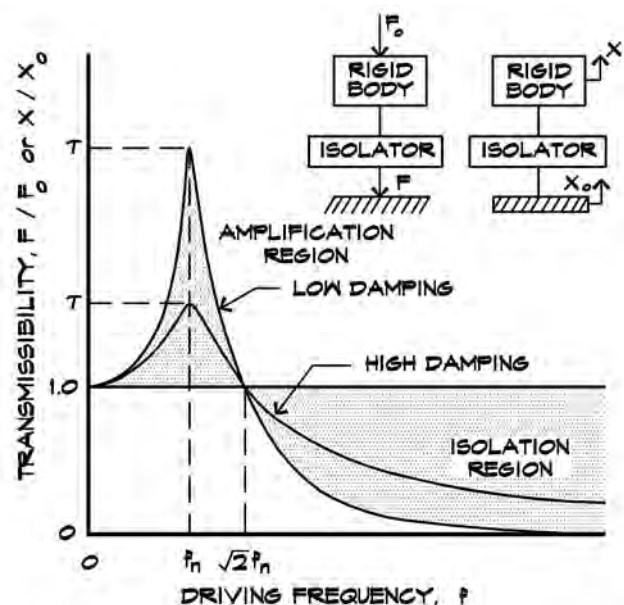
Vibration isolation is a phenomenon associated with a driven spring-mass system as shown in Fig. 1. At low driving frequencies the motion of the mass exactly follows the motion of the driver. As the driving frequency increases, the

mass amplitude reaches a maximum, at the spring-mass resonant frequency. As the driving frequency increases further, the mass amplitude decreases sharply until it falls below the driving amplitude at a frequency above 1.4 times the driv-

Figure 1 also shows the effect of damping on the amount of isolation. Damping has its greatest influence around resonance and is most useful in limiting excursion in this region. Damping actually decreases the amount of isolation which can be achieved. The figure also shows two driving point locations, one directly on the supported mass and the second on the support structure. In the case of studio floors

Fig. 1. Transmissibility curves for vibration isolation (Ruzicka, 1971).
